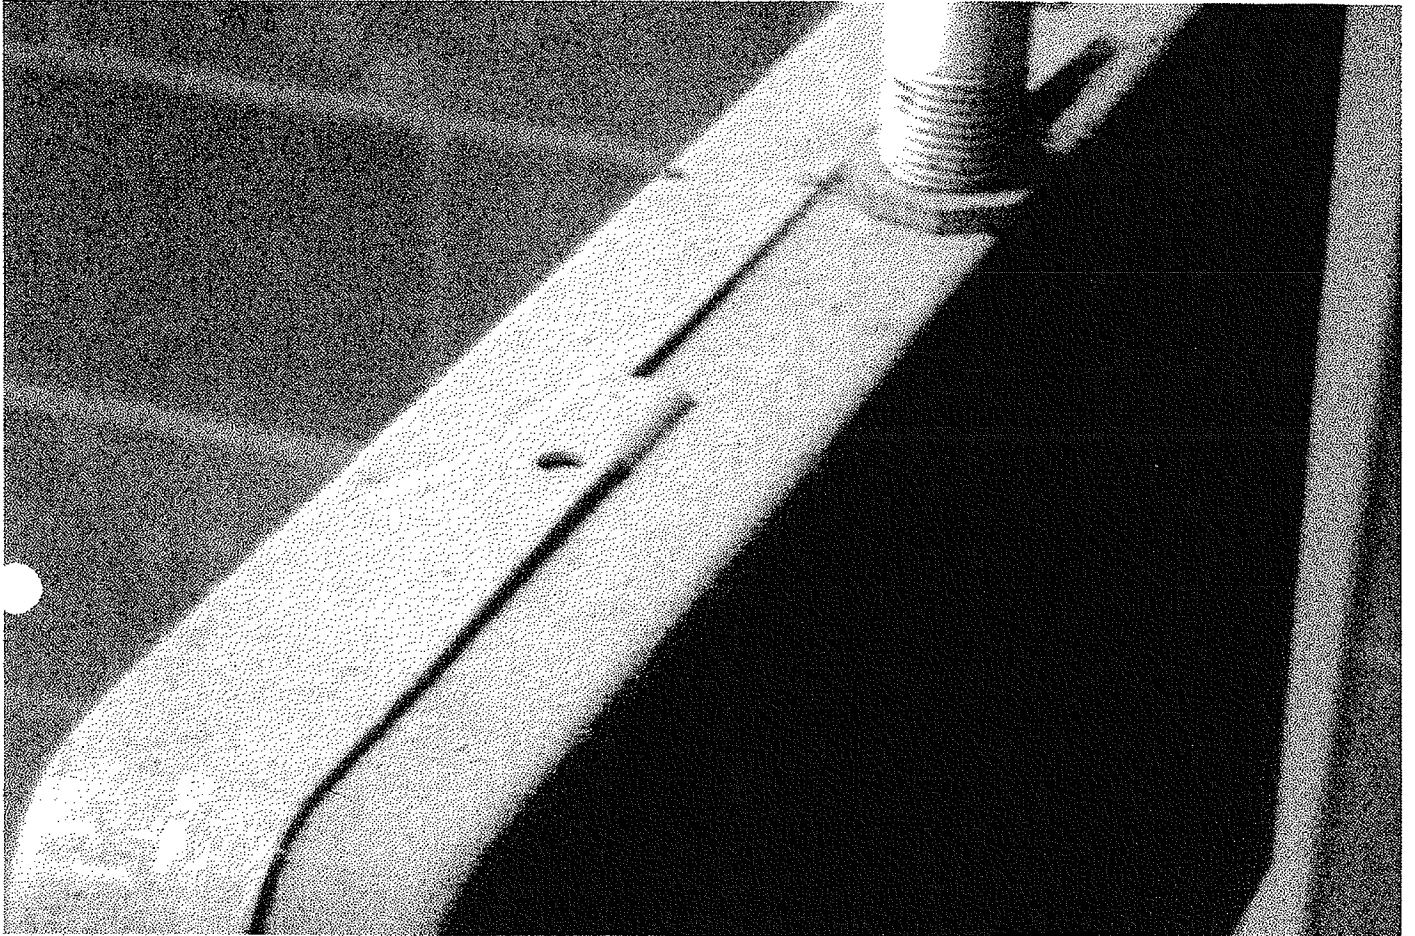
1. rear hall - top of exit sign

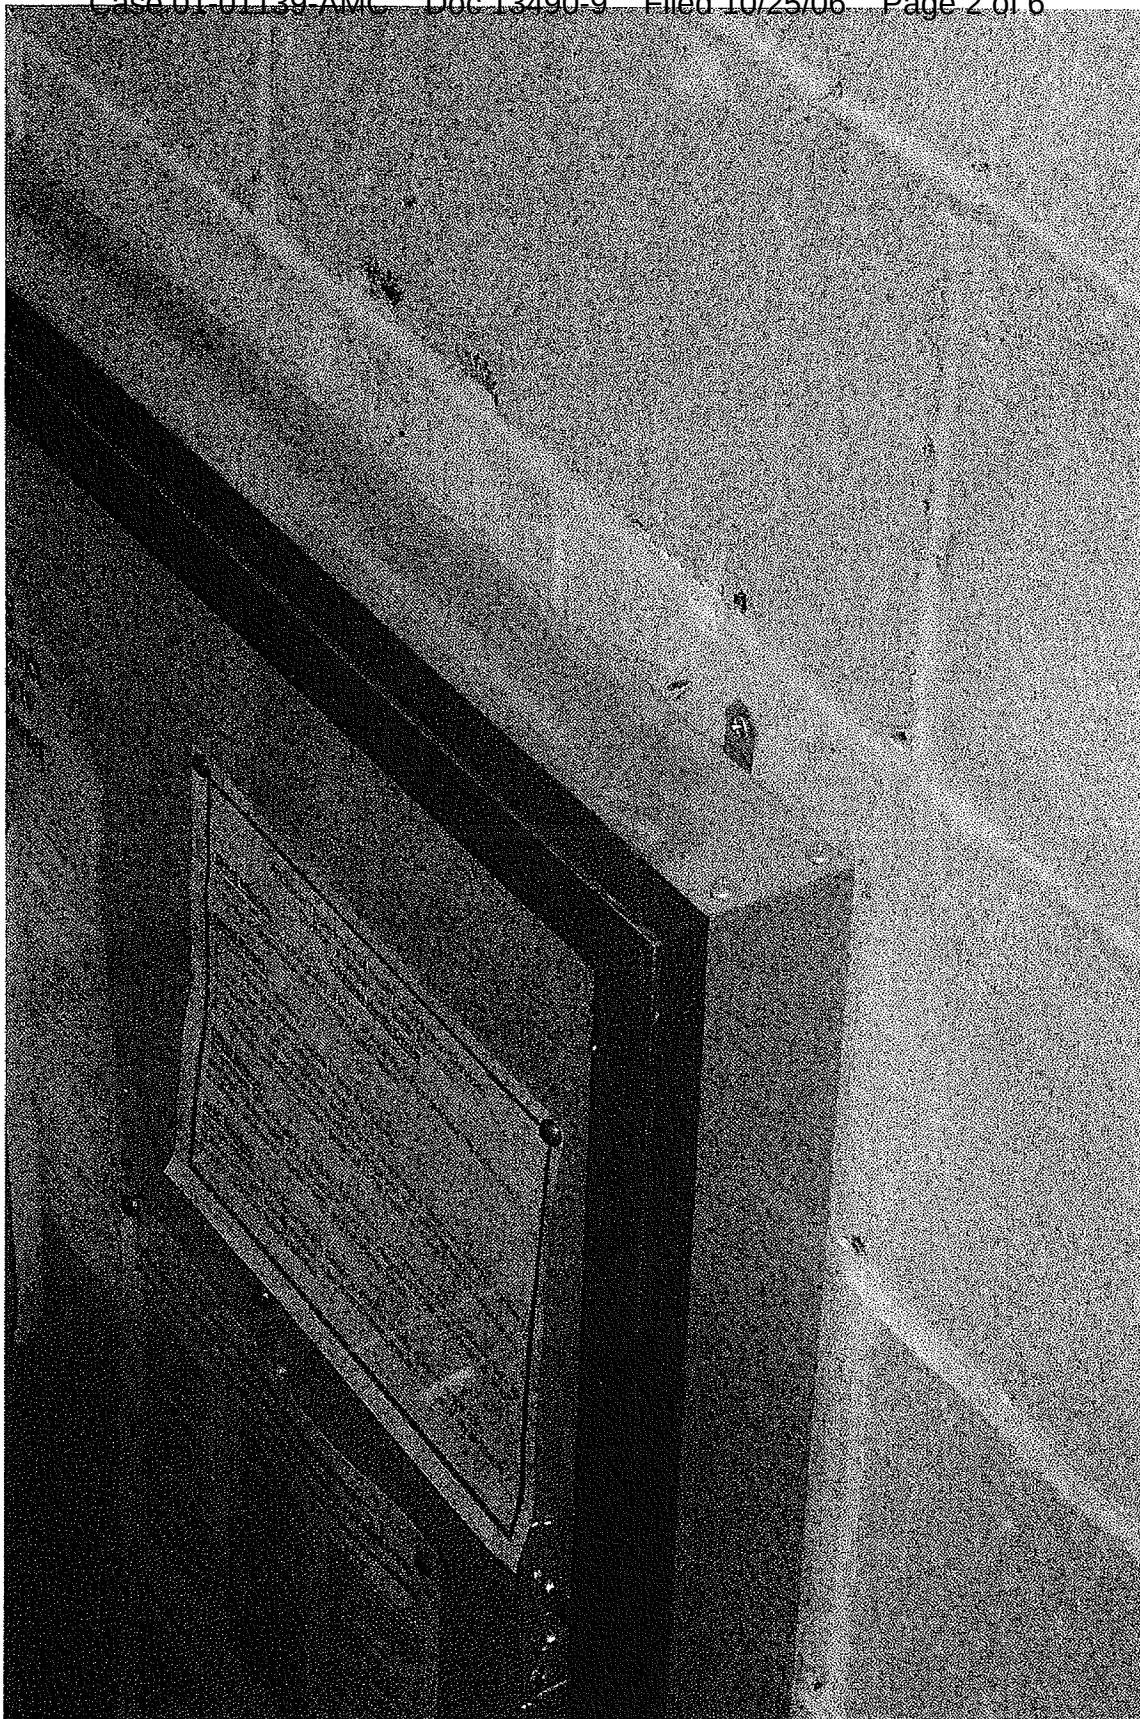
2. rear hall - top of announcement board

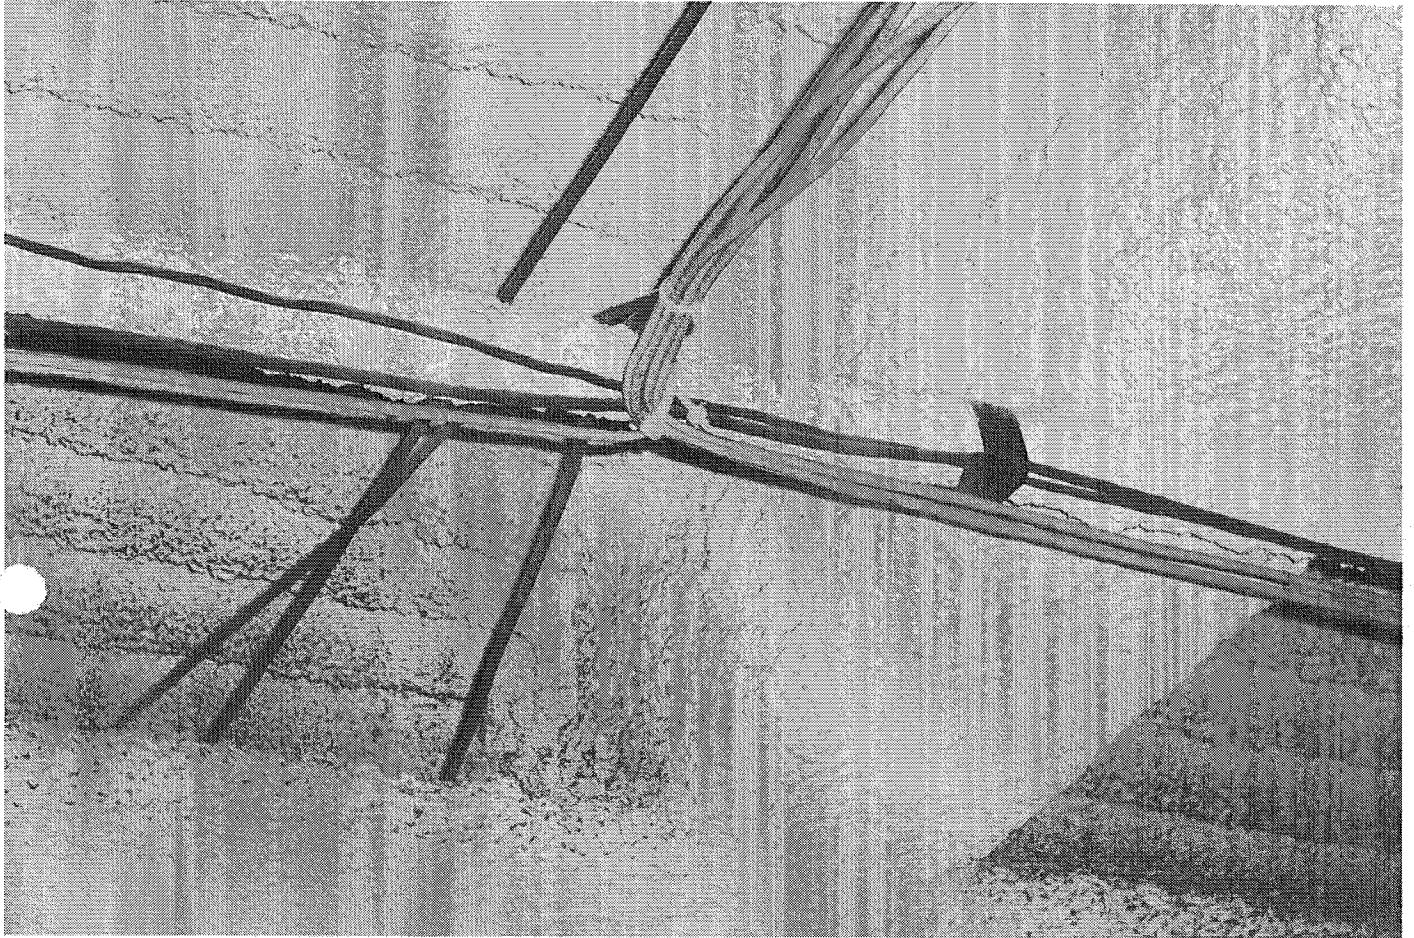
3. rear hall - attachments to fireproofed structural components

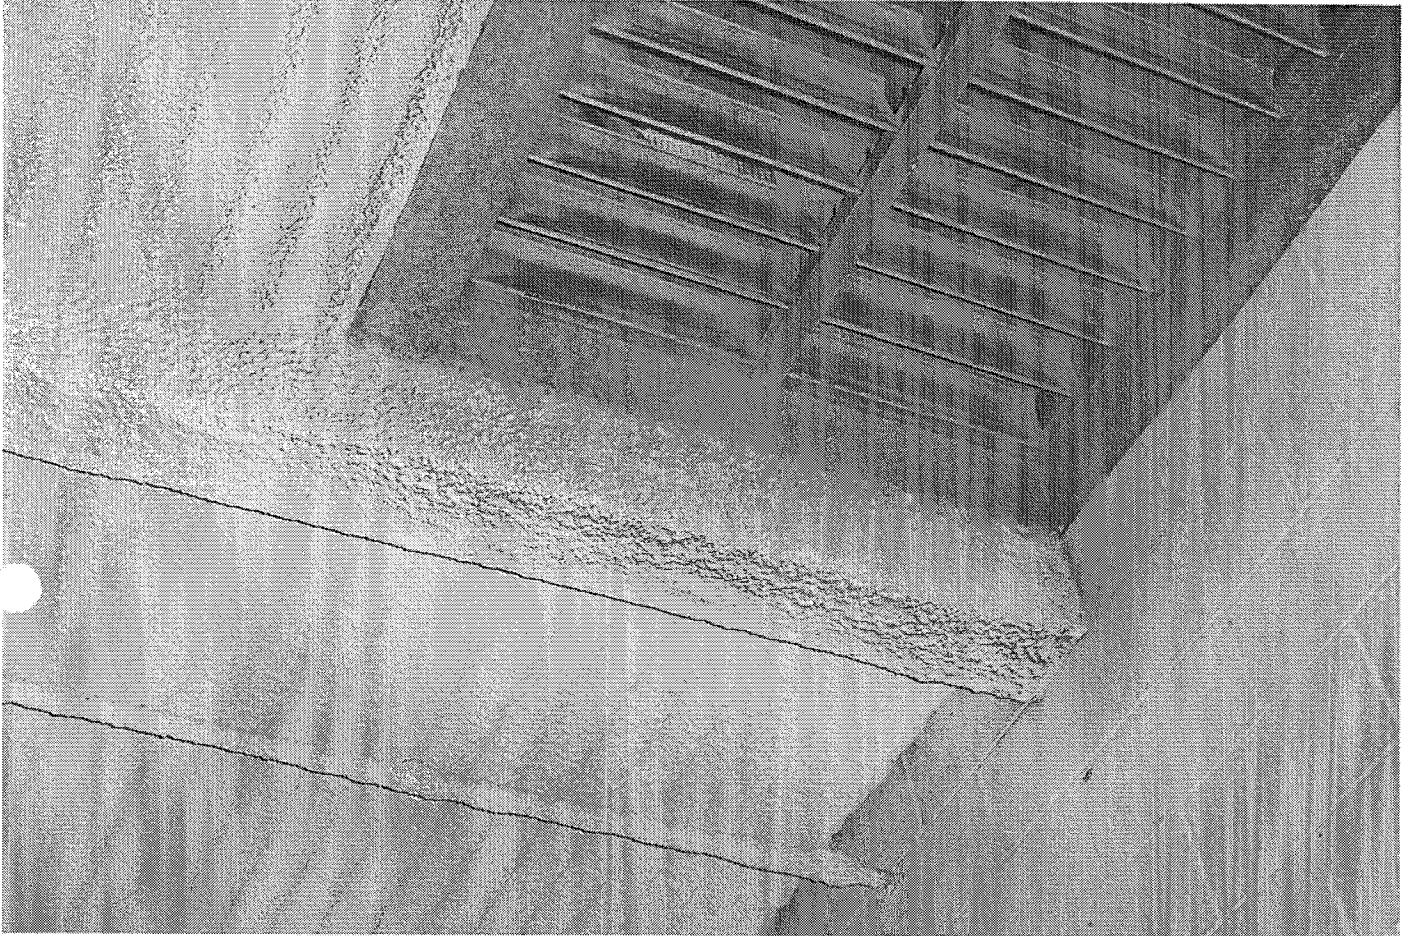
4. rear hall - air erosion around roof exhaust fan

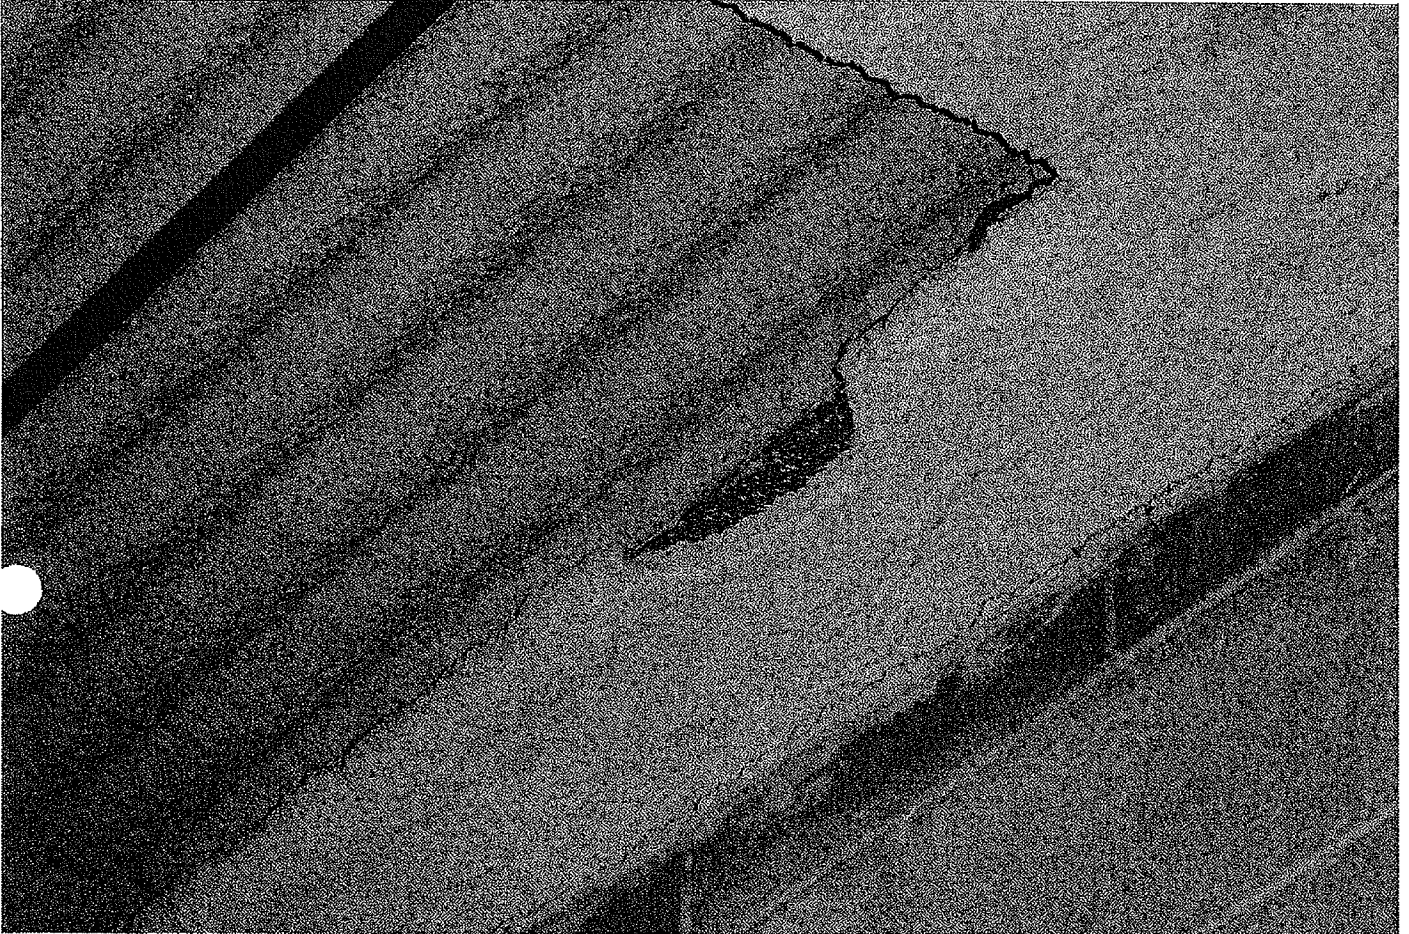
5. plumbing shop - missing fireproofing on I-beam flange

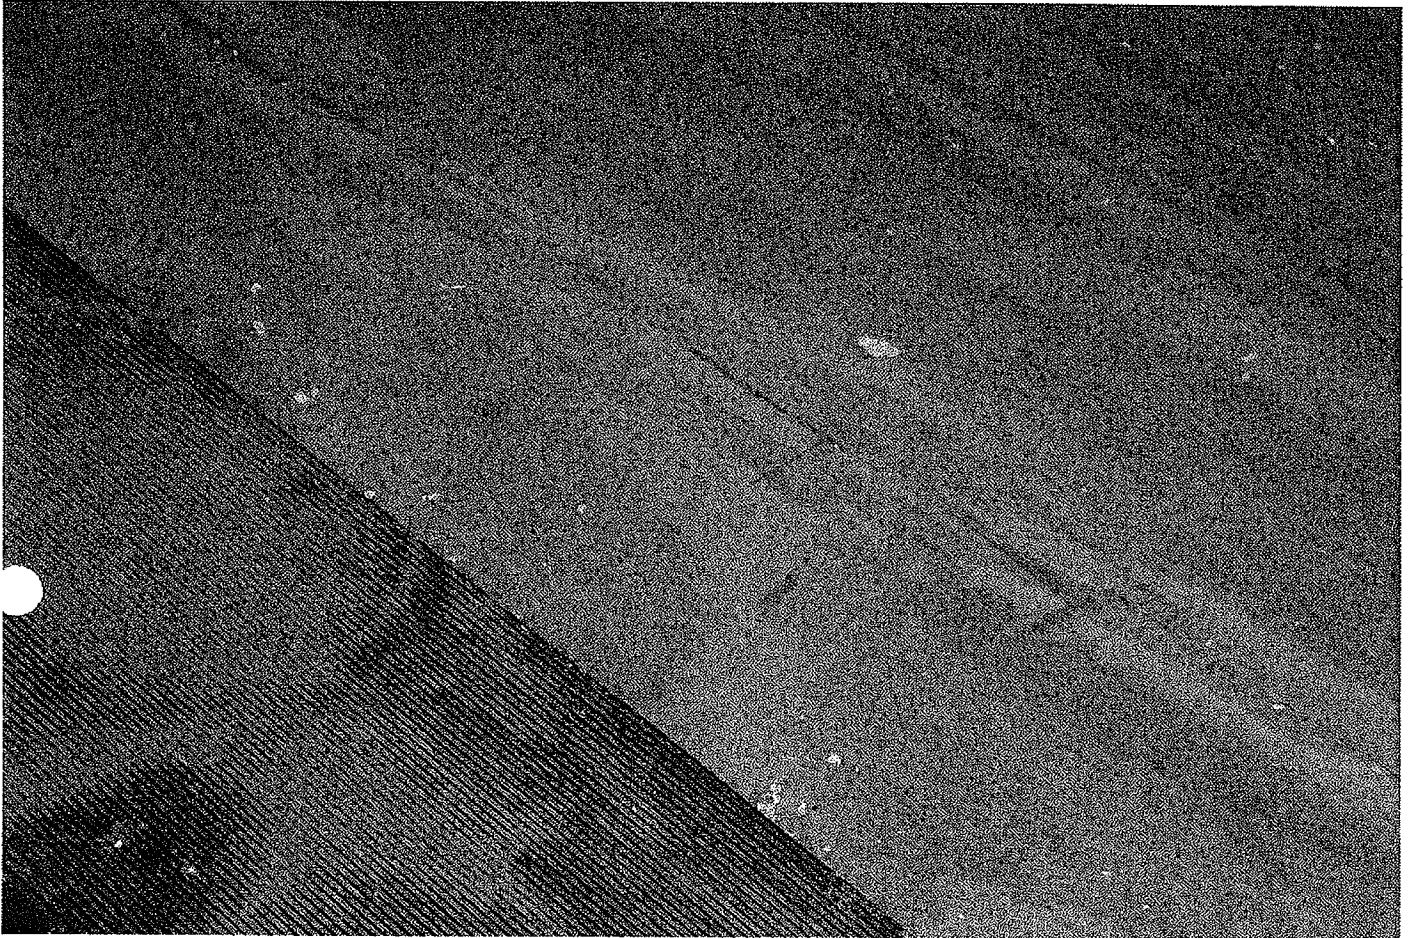
6. plumbing shop - fireproofing debris on top of office plywood decking
